# **Infrared and Ultrasound Technologies – The Perfect Match for Metal-clad Switchgear Inspections**

James Brady, Level-III Certified Thermographer

Brady Infrared Inspections, Inc.  
935 Pine Castle Court, Stuart, FL 34996  
(772) 288-9884

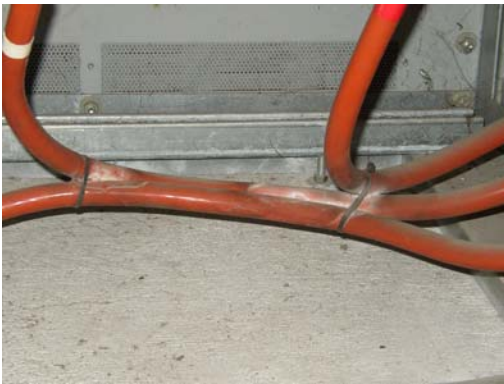
**Figure-4: White powder/dust residue formed on 13kV power cables that are tie-wrapped together forming tight air spaces between each other; ideal locations for corona to form.**

Typically, the effects of corona on rubber-based insulators, tape, and insulation board will leave a white powder residue or dust (Figure-4). This white residue is thought to be the combination of the physical breakdown of rubber based insulation and the accumulation of dust attracted to the conductive air surrounding the corona activity.

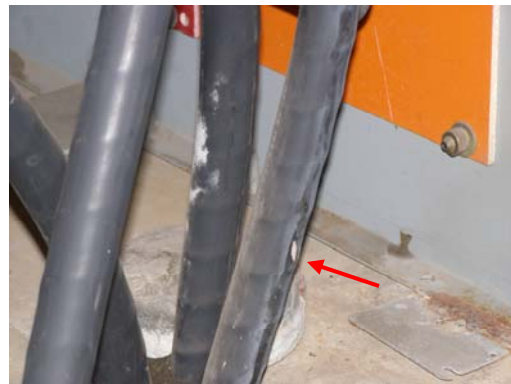
**Figure-5: 13kV power feed cables showing corona powder and a small but intense area of tracking (shown at arrow).**

Others indicators include discoloration and spider cracking on cable insulation. Usually dull finishes and micro-crack stains on cable insulation will be noticed. In worst case scenarios, cables will be severely deteriorated (Figure-5).

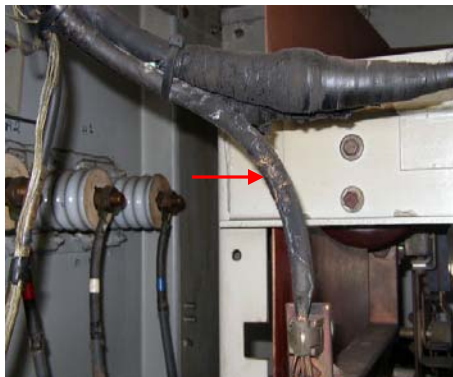
**Figure-6: Severely deteriorated powder feed cable in 4160V switchgear cabinet displaying white powder and carbon tracks at arrow.**

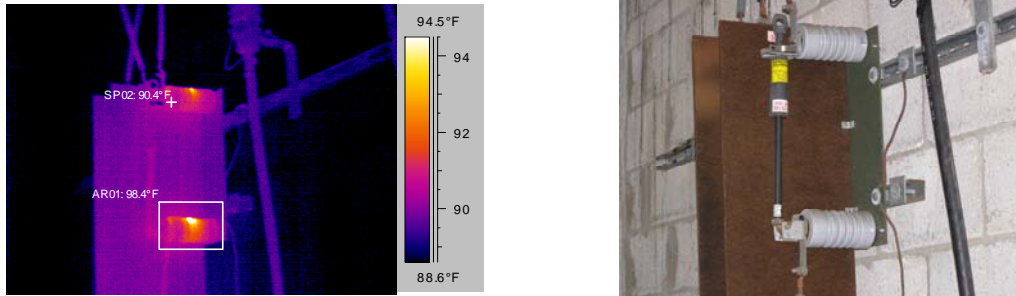
**Figure-8a & 8b: A temperature rise of 8 F-degrees is observed on active corona on a 13kV stand-off bushing for a disconnect switch.**

It has been my experience that most cases of corona produce very little if any heat. Very faint heating patterns may result from the molecular disturbance of electrons associated with the ionization of air (*personal communication with Dan Ninedorf of Ox Creek Energy Associates Inc.*). Depending upon air movement and the intensity of the corona, the delta temperature may or may not be detectable with infrared technology (Figure-8a & 8b). This can be deceiving for the infrared thermographer who is unfamiliar with corona, as this serious condition may only receive a minor severity rating if evaluated solely on temperature rise criteria.

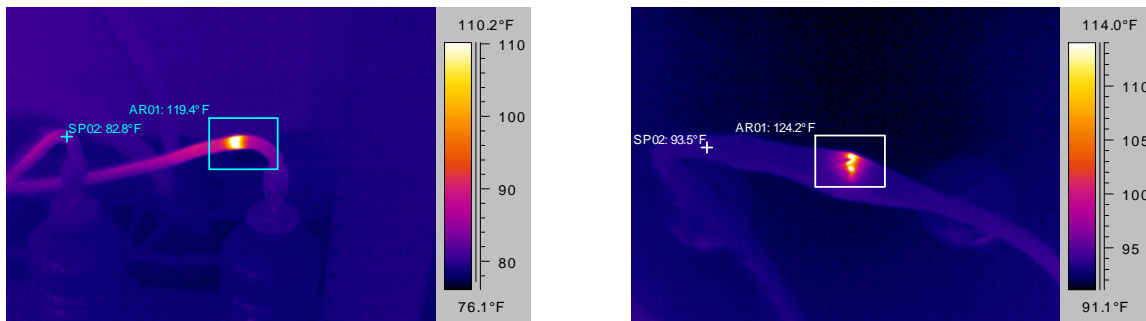
**Figure 9a & 9b: Delta temperatures of over 30F-degrees are seen on conductor cables that having tracking problems.**

In advanced stage where corona has become destructive or is advancing into tracking, I have seen very noticeable delta-temperatures, especially on conductors. Figure 9a and 9B show a examples of such cases.
