Performing A Steam Trap Survey

Brady Infrared Inspections, Inc.

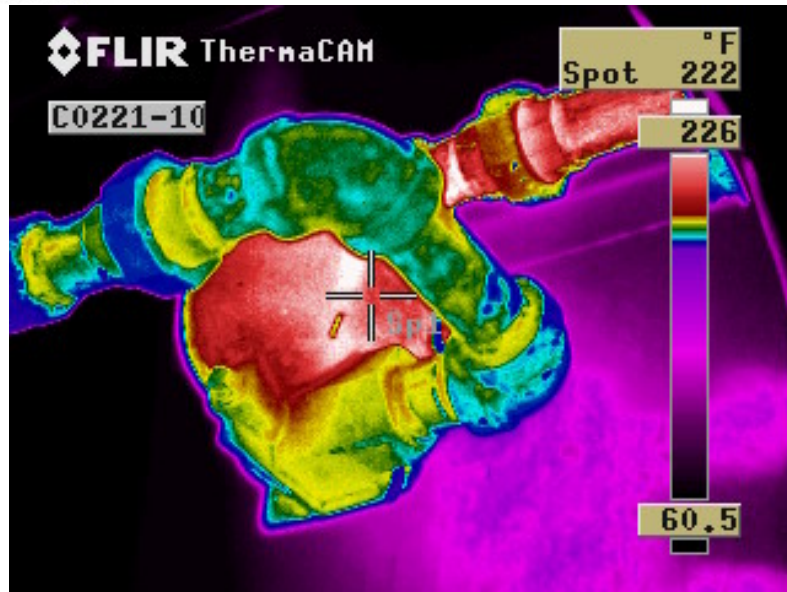
Thermal image of properly working trap

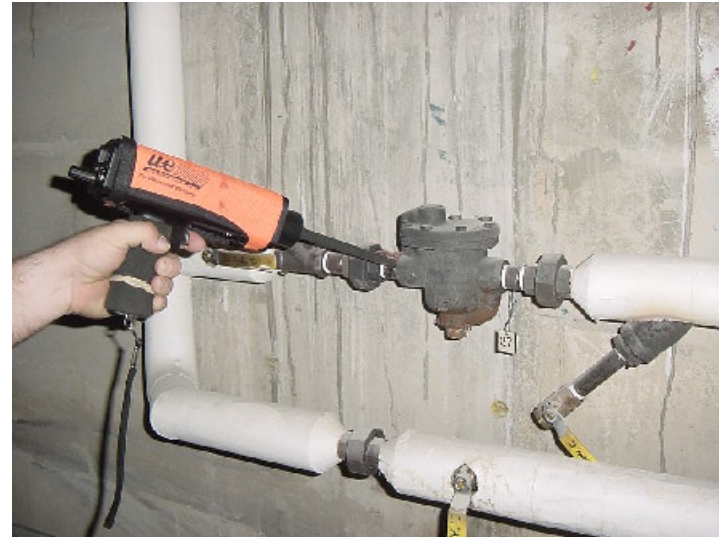
Ultrasound used to detect a trap leaking steam
